1 October 2019

RE: Stage 1 Earthworks Completion Report - Yaldhurst Park, Yaldhurst, Christchurch
(Our Reference: 15518.000.000_16)

1 Introduction

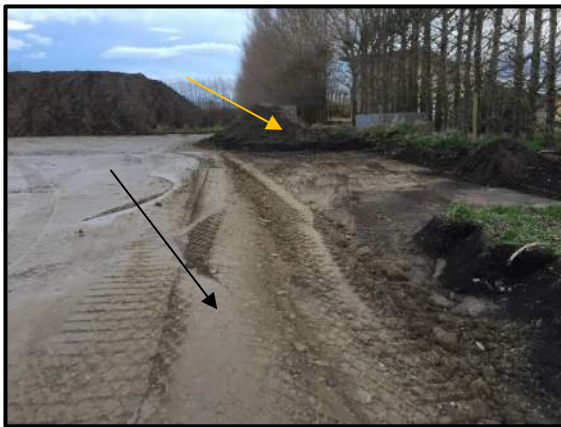
- We observed sandy silt and silty sand with trace organics in the base of the excavations.
- Within the areas of fill (Lots 28 to 34) the upper 200 mm of the subgrade had been excavated and recompacted in accordance with our previous geotechnical recommendations provided in our letter issued on 26 June 2019 (reference: 15518.000.000_06).

- The excavations were moist at the time of our visit.
- Within the right of way on the northern boundary, and within Lots 21, 22, 35 and 36, organic soil, topsoil and fill stockpiles were observed.

Photo 1: Within Lots 22 to 36 the upper 200 mm of the subgrade has been turned and recompactd (black arrow). Organic soil and topsoil stock piles were observed (orange arrow). Photo facing west.

- We recommended that the organic soils and stockpiles be removed, and ENGEO assess the subgrade prior to filling.
- We assessed, with a Scala penetrometer, that a geotechnical ultimate bearing capacity of 200 kPa was available in the subgrade of Lots 22 to 36 at the time of our visit.

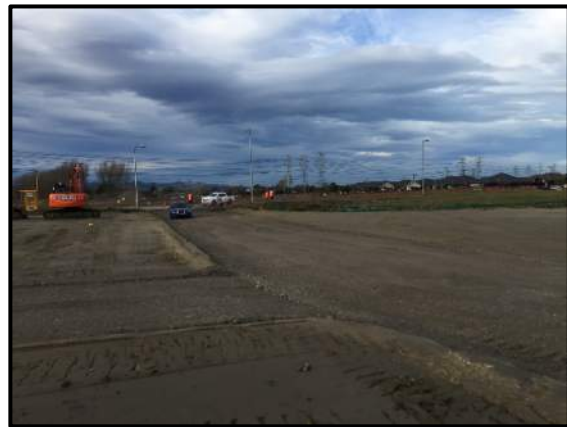
Photo 2: Road 501 had been backfilled with granular fill. Photo facing south.

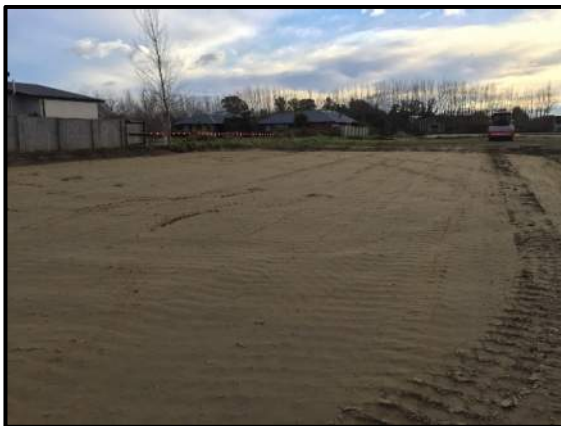
- We observed a combination of cut (native soils) or general fill which comprised of sandy silt and silty sand in the base of the excavations.
- The excavations were moist at the time of our visit.
- We assessed, with a Scala penetrometer, that a geotechnical ultimate bearing capacity of 200 kPa was available in the subgrade of Lots 103, 104, 107 and 108 at the time of our visit.
- 200 mm to 300 mm of topsoil was then placed per the proposed design.

Photo 3: Lots 107 and 108 following compacted engineered fill suitable for topsoil placement. Photo facing north.

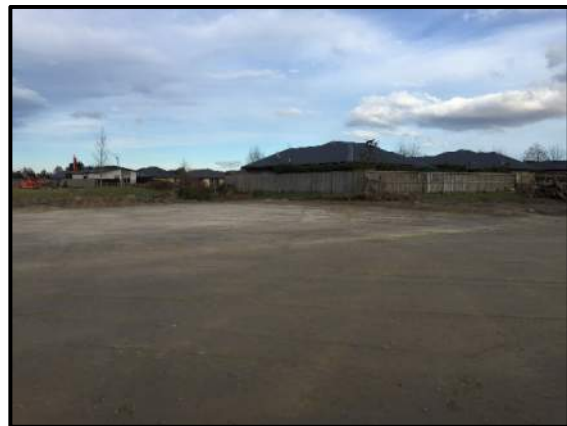
Photo 4: Lots 103 and 104 following compacted engineered fill suitable for topsoil placement. Photo facing west.

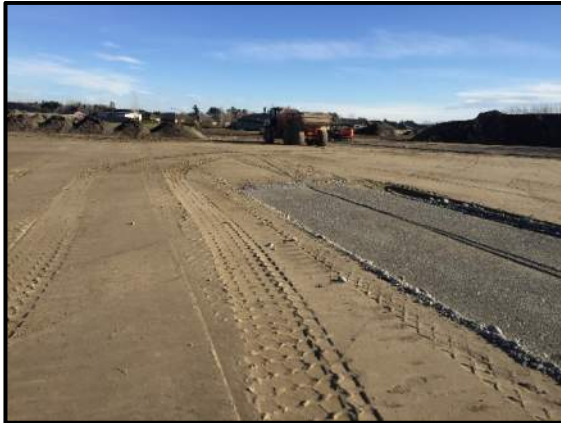
- General fill which comprised of sandy silt and silty sand was observed in the base of the excavations.
- The excavations were moist to saturated at the time of our visit.
 - We recommended that the localised areas which have standing water (as a result of the recent rainfall event during the weekend) be left to dry out prior to placement of topsoil.
- Through discussions with Dormer construction on-site, the areas of fill were a maximum of 400 mm deep (two layers of fill).
 - 200 mm to 300 mm of topsoil was then placed per the proposed design.

Photo 5: View over Lots 25 to 32 prior to topsoil placement. Photo facing southwest.

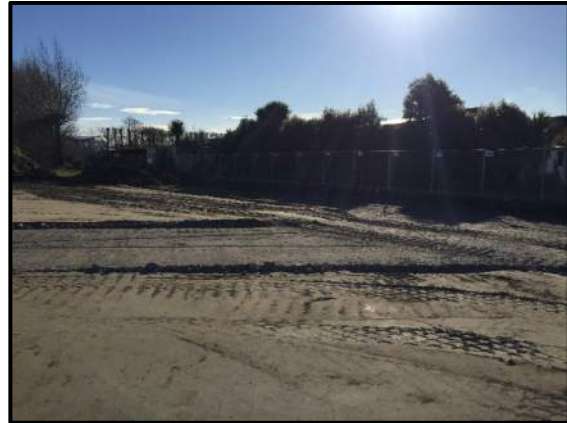
- Within the right of way on the northern boundary, and within Lots 34, 35 and 36, organic soil, topsoil and fill stockpiles were observed.
 - We recommended that the organic soils and stockpiles be removed and ENGEO assess the subgrade prior to filling.
- We observed granular gravel fill in the base of the right of way directly adjacent to Lot 34 and partially adjacent to Lot 35.
 - Through discussions with Dormers during our site visit, we understand that this area had been over excavated approximately 100 mm below adjacent ground level into native silt or sand, and backfilled with compacted granular fill. ENGEO did not observe the base of this right of way excavation prior to filling.
 - This was completed by Dormer construction prior to our site visit as a “temporary” measure to enable service installation during winter.

Photo 6: View over Lots 34 to 36. Photo facing northwest.

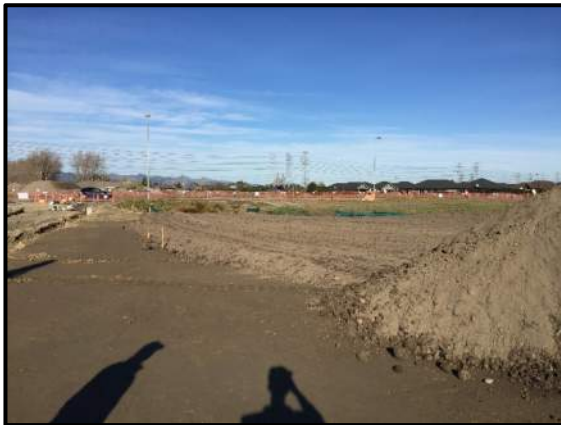
- Topsoil has either been placed or was in the process of being placed on Lots 103, 104, 107 and 108 at the time of our visit.
- Through discussions with Dormers during our site visit, topsoil from Lot 109 was excavated and “flipped” onto the adjacent lots (107 and 108) to enable ENGEO to observe the base of the excavation.
- The excavations were moist at the time of our visit.

Photo 7: Topsoil placed on Lot 104. Photo facing south.

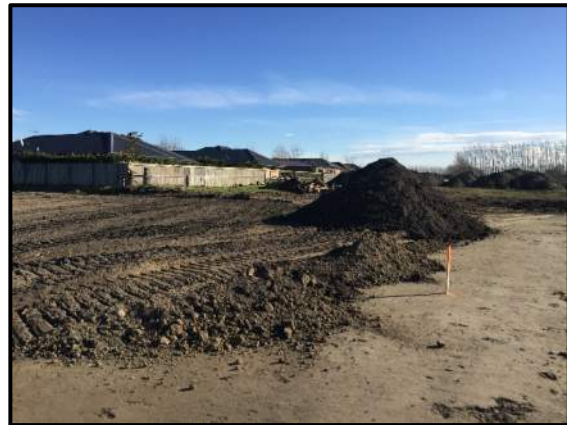
Photo 8: Topsoil being placed on Lot 103. Photo facing west.

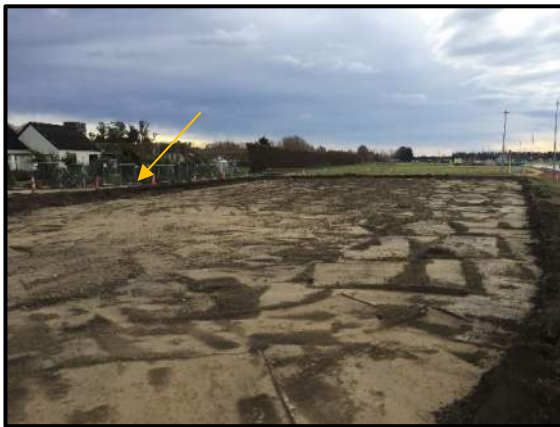
- Approximately 70% of excavation was completed across Lots 37 to 40 during our site visit. The remaining 30% of the excavation has been left to enable access to neighbouring properties. This area will be excavated and filled following the installation of a new right-of-way at a later date.
- We observed sandy silt and silty sand with trace organics in the base of the excavations.
- The excavations were moist at the time of our visit.
- We assessed, with a Scala penetrometer, that a geotechnical ultimate bearing capacity of 200 kPa was available in the subgrade of Lots 37 to 40 at the time of our visit.
- We understand that approximately 300 mm to 400 mm of general fill (at the deepest) was then placed across Lots 37 to 40.

Photo 9: View of Lots 37 to 40. Right of way to be over excavated observed (orange arrow). Photo facing north.

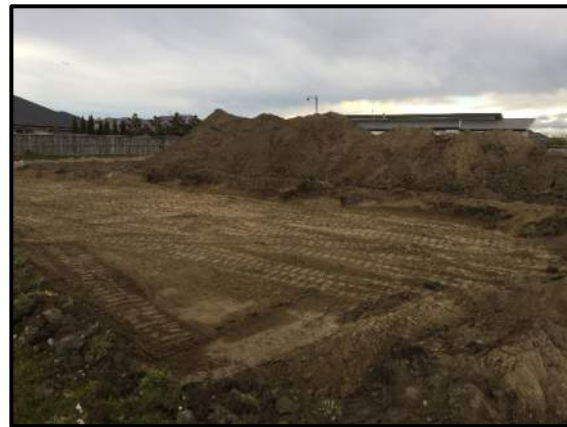
- We observed sandy silt and silty sand with trace organics in the base of the excavation.
- The excavation was moist at the time of our visit.
- We assessed, with a Scala penetrometer, that a geotechnical ultimate bearing capacity of 200 kPa was available in the subgrade of Lot 109 at the time of our visit.
- We understand that approximately 400 mm to 500 mm of general fill (at the deepest) was then placed across Lot 109.

Photo 10: Lot 109 with topsoil stockpiled adjacent to the excavation. Photo facing southwest.

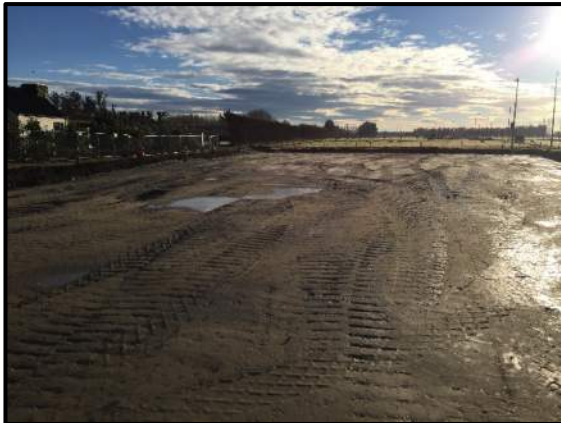
- General fill which comprised of sandy silt and silty sand was observed in the base of the excavations.
 - Through discussions with Dormer construction on-site, the areas of fill were a maximum of 400 mm deep (two layers of fill).
 - 200 mm to 300 mm of topsoil was then placed per the proposed design.
- Excavations were moist to saturated at the time of our visit.
 - We recommended that the localised areas which have standing water (as a result of the recent rainfall) be left to dry out prior to placement of topsoil.

Photo 11: Lots 37 40 following placement of engineered fill. Note areas of saturated soil.

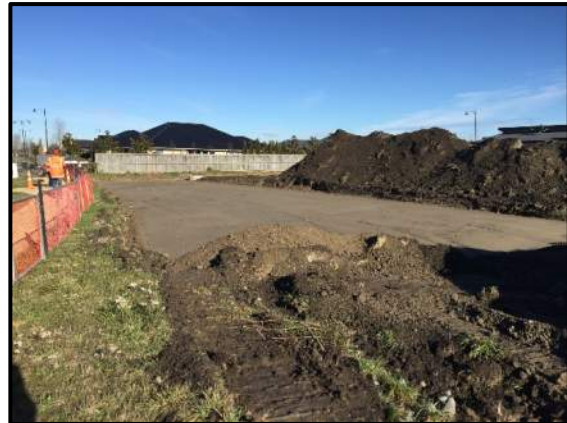
- General fill which comprised of sandy silt and silty sand was observed in the base of the excavations.

Photo 12: Lot 109 following placement of engineered fill. Photo facing southwest.

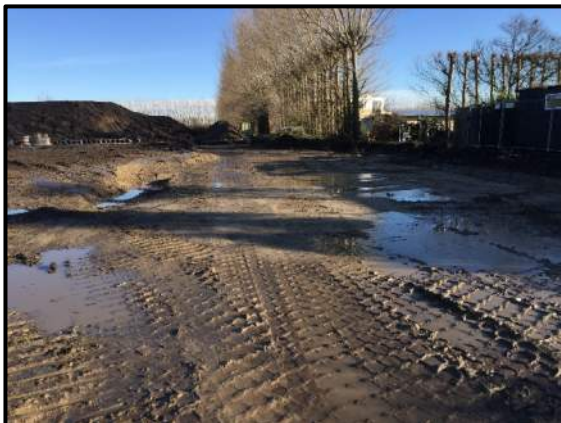
- We observed the subgrade of Lots 35 and 36 which comprised sandy silt and silty sand with trace organics in the base of the excavations.
- We assessed, with a Scala penetrometer, that a geotechnical ultimate Bearing capacity of 200 kPa was available in the subgrade of Lots 35 to 36 at the time of our visit.
- We assessed, then when using Austroads Guide to design part 2 (2019), that a CBR of at least 6% was available in the base of the right of way excavation.
- A service trench was excavated on the northern perimeter of the right of way.
- The excavations were wet to saturated at the time of our visit.
- 200 mm to 300 mm of topsoil was then placed per the proposed design.

Photo 13: Lots 35 and 36. Note standing water in the base of the excavation. Photo facing west.

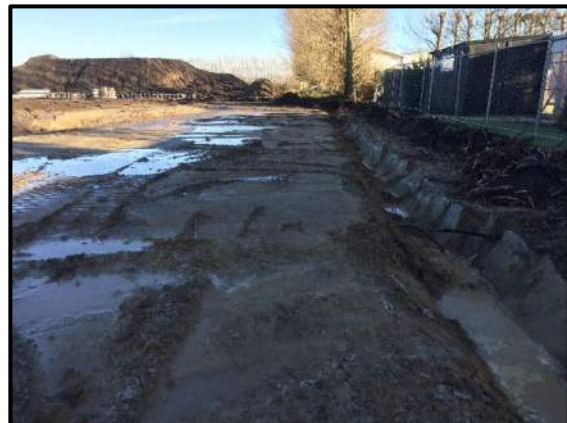
Photo 14: Service trench excavated on the northern perimeter of the right-of-way. Photo facing west.

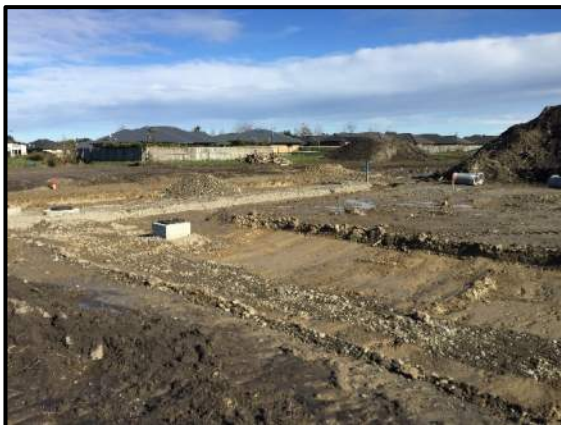
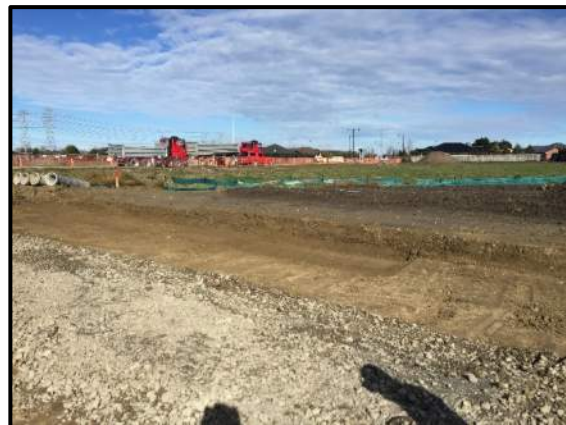
- We observed native sandy silt and silty sand in the base of most of the excavations.
 - Within the centre of the roads, the service trenches had been excavated and backfilled with compacted AP65. Through discussions with the contractor, the hardfill was placed in 200 mm layers and compacted to at least 95% of MDD.

- We observed some localized areas of organic soil, uncontrolled fill and soft silt during our site visit.
 - We recommended these areas of organic soil, uncontrolled fill and soft soil be over excavated and backfilled with compacted pit run material. This was being completed during our visit.

- The excavations were moist to wet at the time of our visit.
- We assessed, with a Scala penetrometer, that a geotechnical ultimate bearing capacity of 200 kPa was available in the base of the right of way excavations.

- We assessed, then when using Austroads Guide to design part 2 (2019) standard, that a CBR of at least 6% was available in the base of the right of way excavations.

Photo 15: View of the road 501 and adjacent. Photo facing southwest.

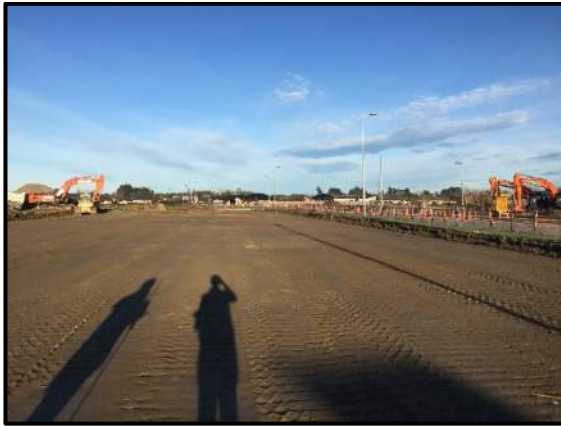
- We observed sandy silt and silty sand with trace organics in the base of the excavations.
- The excavations were moist at the time of our visit.
- We understand that the subgrade had been proof rolled prior to our site visit.
- We assessed, with a Scala penetrometer, that a geotechnical ultimate bearing capacity of 200 kPa was available in the subgrade of Lots 85 to 90 at the time of our visit.
- We understand that approximately 100 mm of general fill (at the deepest) was then placed across Lots 85 & 86.

Photo 17: View of Lots 85 to 90. Photo facing southwest.

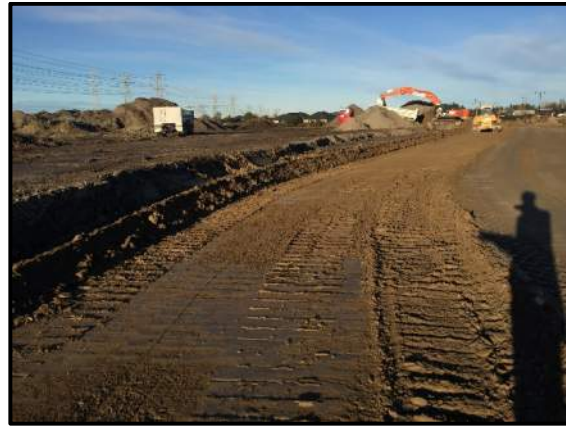
- We observed sandy silt and silty sand with trace organics in the base of the excavations.
- The excavations were moist at the time of our visit.
- Some loose soil was observed in the base of the road excavation.

Photo 18: View over right of way (Lot 300) adjacent to Lots 85 to 90. Photo facing southwest.

- We recommended that the loose soil be removed prior to importation of pit run fill.
- The excavations were moist to wet at the time of our visit.
- We assessed, with a Scala penetrometer, that a geotechnical ultimate bearing capacity of at least 200 kPa was available in the base of the right of way excavations at the time of our visit.

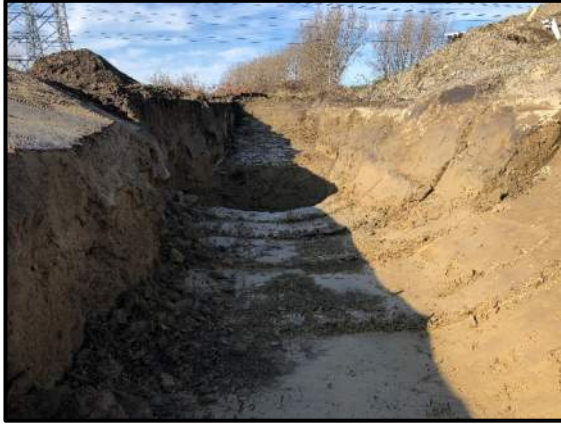
- The rubbish was excavated from the trench and disposed off-site prior to our site visit.
- We observed sandy silt and silty sand with trace organics in the base of the excavation.

- The excavation was moist to wet at the time of our visit.
- We assessed, with a Scala penetrometer, that a geotechnical ultimate bearing capacity of at least 200 kPa was available in the subgrade of the trench at the time of our visit.

Photo 19: Rubbish trench excavation. Photo facing southeast.

- We recommended that area which was over excavated to gravel be backfilled with angular ballast (or equivalent).
 - The ballast comprised of 40 mm to 60 mm crushed rock with no fines. The ballast was wrapped in geotextile (Bidim A29 or AS410, or equivalent).

To minimise the potential for differential fill settlement across Lot 76, we recommended the following sequence be implemented:

- Re-place site won silt spread uniformly in layers having a loose thickness no greater than 200 mm maximum, compacted to a minimum of 95% Maximum Dry Density.

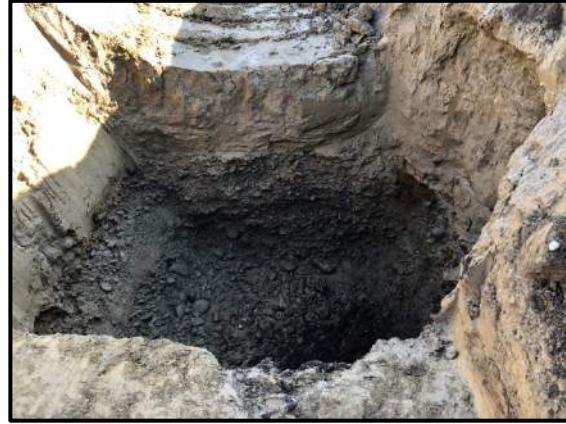
Photo 20: Deepened excavation to gravel layer approximately 2.5 m bgl.

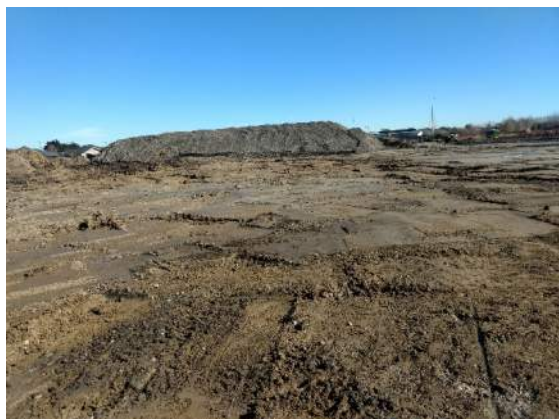
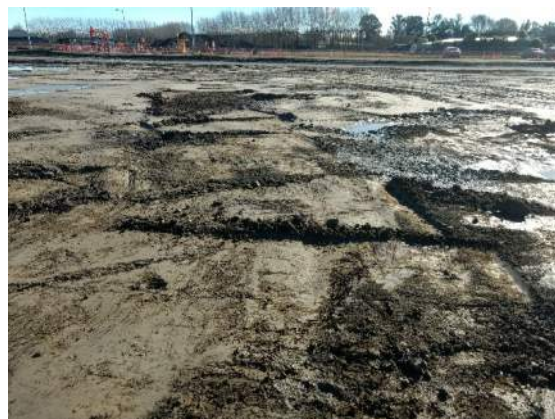
- We observed sandy silt and silty sand with trace organics in the base of the excavations.
- The excavations were moist at the time of our visit.
- We understand that the subgrade had been proof rolled prior to our site visit.
- We assessed, with a Scala penetrometer, that a geotechnical ultimate bearing capacity of 200 kPa was available in the subgrade of Lots 79 to 84 at the time of our visit.
- We understand that approximately 100 mm to 200 mm of general fill (at the deepest) was then placed across Lots 79 to 84.

Photo 21: View of Lots 79 to 84. Photo facing southwest.

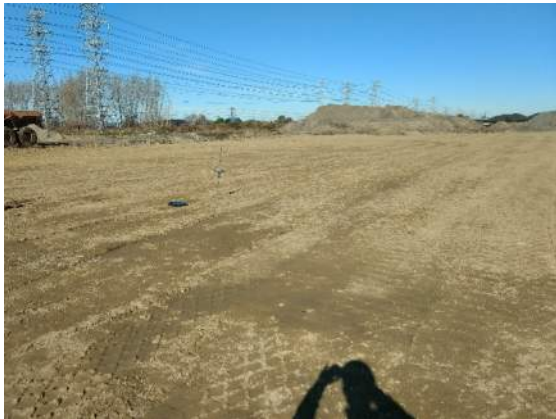
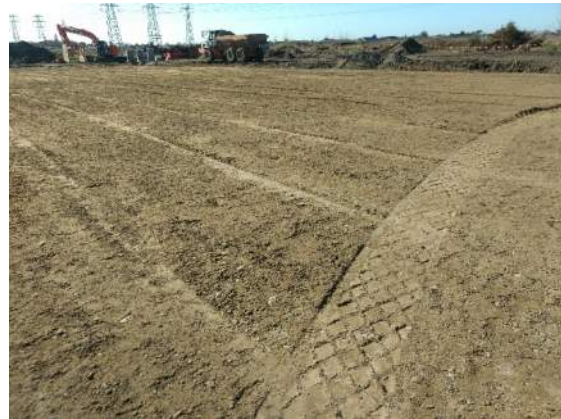
- General fill which comprised of sandy silt and silty sand was observed in the base of the excavations.
 - Through discussions with Dormer construction onsite, the areas of fill were a maximum of 200 mm deep (one layer of fill).
- The excavations were moist to wet at the time of our visit.
 - We recommended that the localised areas which had standing water (as a result of the recent rainfall) be left to dry out, statically re-compacted and re-compaction tested prior to placement of topsoil.
- 200 mm to 300 mm of topsoil was then placed per the proposed design subject to drying or removal of the standing water.

Photo 23: View of Lots 79 to 84. Photo facing southwest.

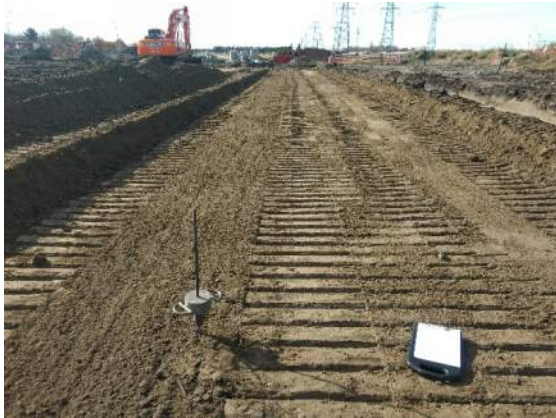
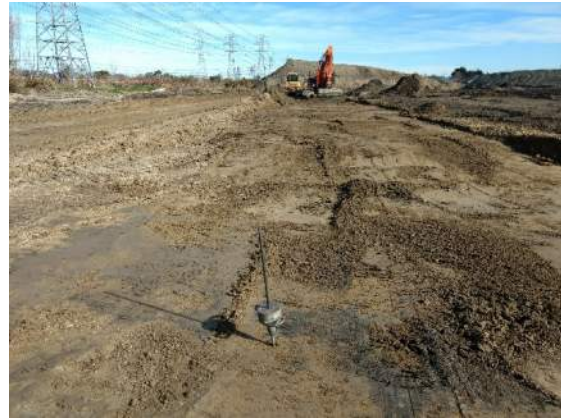
- The proposed right of way had been excavated approximately 0.2 m below design subgrade level to allow for imported pit run to be placed as a working platform for service installation.
- We observed sandy silt and silty sand with trace organics in the base of the excavations.
- The excavations were moist at the time of our visit.
- Some loose soil was observed in the base of the road excavation.
 - We recommend that the loose soil is removed prior to importation of pit run
- The excavations were moist to wet at the time of our visit.
- We assessed, with a Scala penetrometer, that a geotechnical ultimate bearing capacity of at least 200 kPa was available in the base of the right of way excavations at the time of our visit.

Photo 25: View right of way 301. Photo facing northeast.

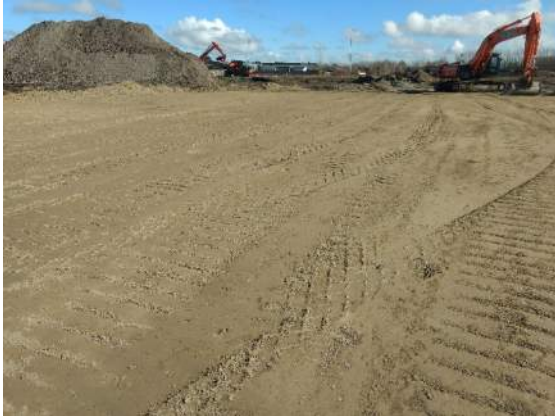
- General fill which comprised of sandy silt and silty sand was observed in the base of the excavations.
 - Through discussions with Dormer construction onsite, the areas of fill were a maximum of 200 mm deep (one layer of fill).
- The excavations were moist at the time of our visit.
- 200 mm to 300 mm of topsoil was then placed per the proposed design.

Photo 27: View Lots 73 to 78. Photo facing southwest.

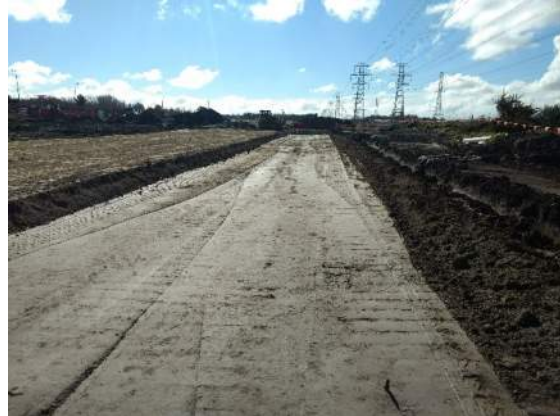
Photo 28: View right of way 301. Photo facing northeast.

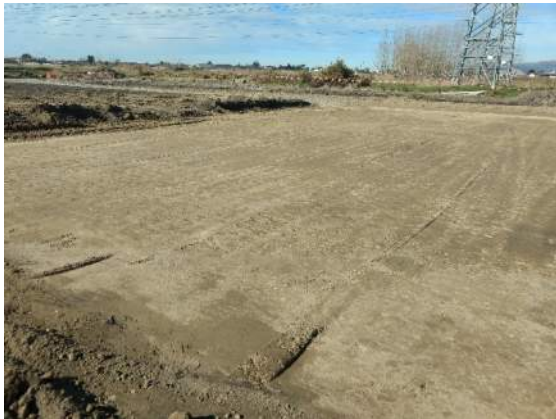
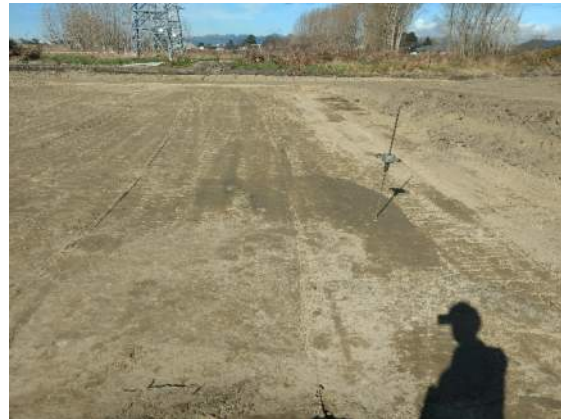
- To minimise the potential for differential fill settlement across Lot 76, A minimum of 500 mm (below the topsoil layer) was excavated across the entire lot area and replaced with site won silt which was spread uniformly in layers having a loose thickness no greater than 200 mm maximum, and compacted to a minimum of 95% Maximum Dry Density.
- General fill which comprised of sandy silt and silty sand was observed in the base of the excavations.
- The excavations were moist at the time of our visit.
- Through discussions with Dormer construction onsite, the areas of fill were a maximum of 2 m deep (10 layers of general fill) plus an additional area of over-excavation (2 m by 2m) approximately 3 m bgl.
- 200 mm to 300 mm of topsoil was then placed across Lot 76 per the proposed design.

Photo 29: Lot 76 with the entire area over excavated and recompacted. Photo facing east.

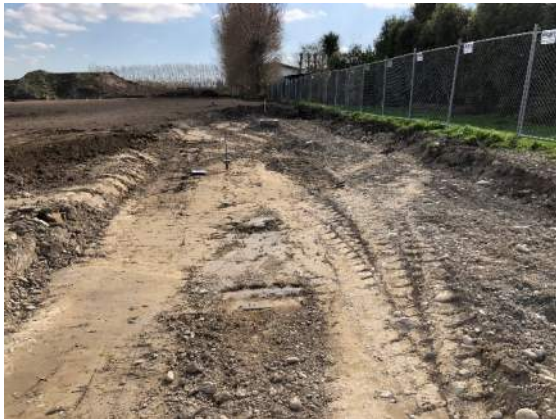
- We observed sandy silt, silty sand with trace organics, and compacted hardfill in the base of the excavations.
 - Hardfill was observed in the base of the excavations from the trenched excavations for service installation. The trenches were backfilled with compacted hardfill following service installation.

- The excavations were moist at the time of our visit.
- Some loose soil was observed in the base of the right of way excavation.
 - We recommended that the loose soil is removed prior to importation of pit run fill

Photo 31: View of right of way 4. Photo facing west.

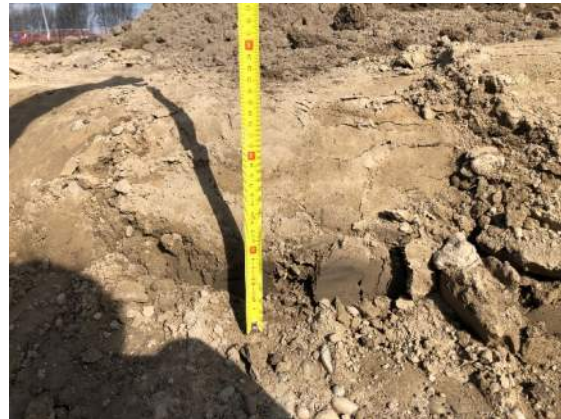
Photo 32: Depth of excavation below subgrade level to allow for backfill of pit run (subbase).

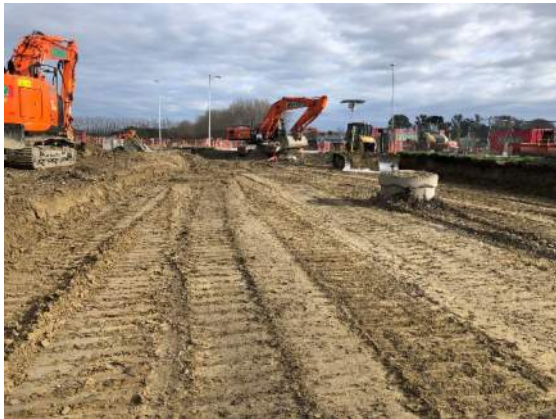
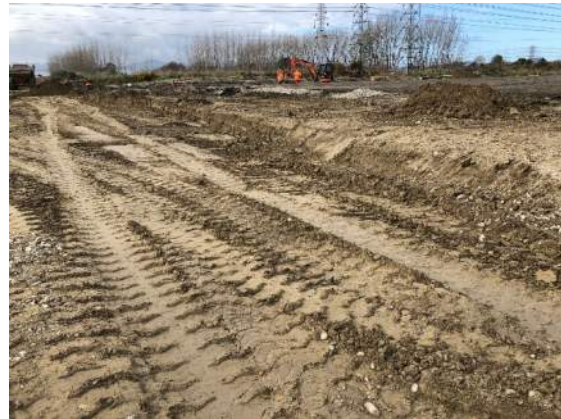
Photo 33: View of road 507. Photo facing west.
