Geotechnical Investigation - Stage 1

Yaldhurst Park

Yaldhurst

Infinity Yaldhurst Limited

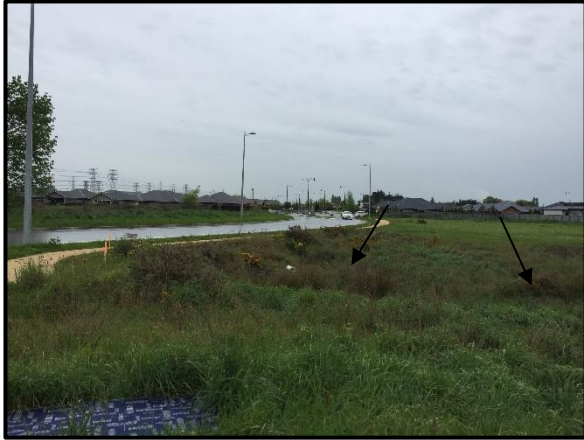
- Stage 1 of the subdivision is currently partially developed from the previous developer with some formed roads, partially formed roads, partially formed lots, public recreation areas and stormwater basins (Photo 1).

Photo 1: Stage 1 of Yaldhurst Park Subdivision development. Stream described above in the foreground (black arrow).

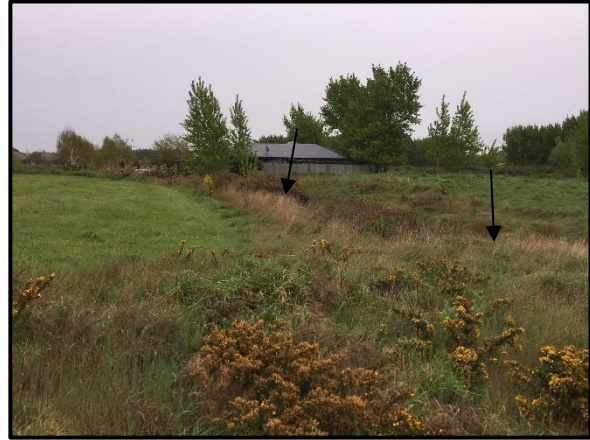
- A stream is running east to west on the southern side of stage 1 of the development and the base of the streambed is approximately 1.5 m below adjacent ground level (Photos 1 & 2). Approximately 200 mm to 400 mm of water was observed in the base of the stream at the time of our site visit. It was proposed by the client that the stream is planned to be diverted during the earthworks stage of development.

Photo 2: Stream observed on the south side of the stage 1 development.

Where the stream is planned to be diverted, directly effecting Lots 105 and 106, any soft, wet, and organic soils should be removed prior to placement of engineered fill. The engineered fill should be benched into the sides of the former stream bank and the differential fill thickness under specific building footprints should be less than 1.5 m. We will provide a subsequent document with specific earthworks recommendations for the proposed diversion of the stream.

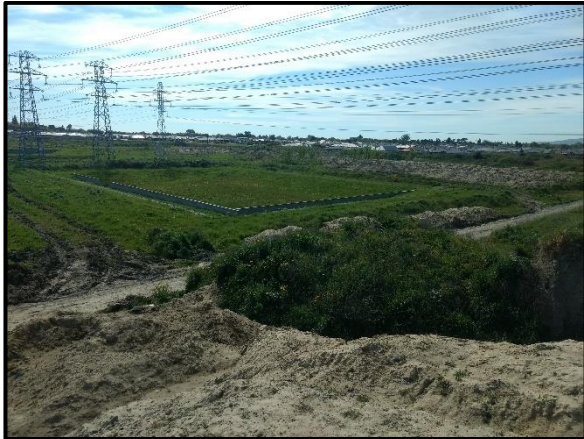
Photo 3: Row of electrical tower pylons with adjacent stormwater retention basins observed. Silt and fill stockpiles observed in the foreground.

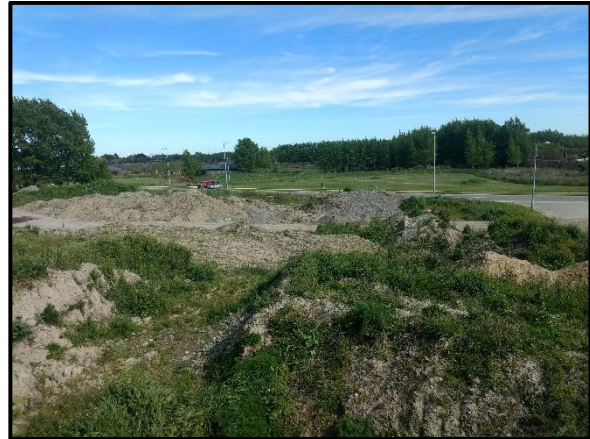
- A row of electrical tower pylons run through the proposed development with retention basins constructed adjacent to the pylons (Photo 3).
- In area 1C of Stage 1, a series of fill, silt and unknown material stockpiles were observed (Photo 4). Through discussions with the client, these stockpiles are to be removed or re-used (depending on soil type) during the proposed earthworks and development of the site.

Photo 4: Silt, fill and unknown material stockpiles observed in section 1C of the proposed stage 1 development.
