Yaldhurst Park
Yaldhurst
Christchurch

Infinity Yaldhurst Limited
PO Box 390
Wanaka

ENGEO Limited

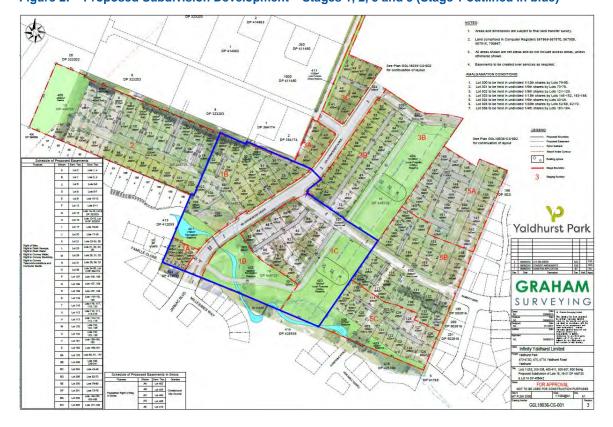
Figure 2: Proposed Subdivision Development – Stages 1, 2, 3 and 5 (Stage 1 outlined in blue)

The predominantly flat, to gently undulating site is partially developed land with stockpiled silt, fill, and unknown material observed in areas '1C' and areas '5A', '5B' and '5C' on the southern and eastern sides of the proposed development (Figures 2 & 3).

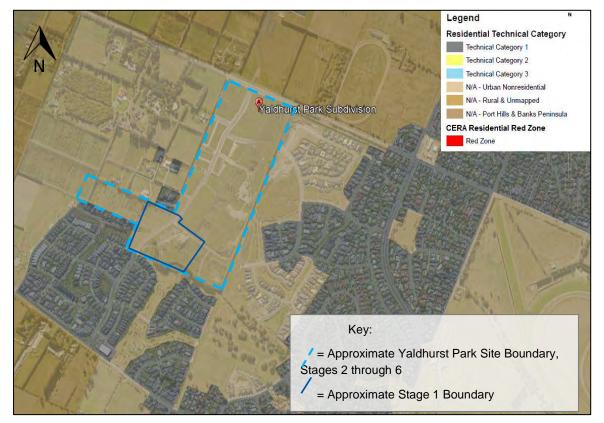
Figure 5: MBIE Residential Technical Categories Overlay

The Canterbury Earthquake Recovery Authority (CERA, now disestablished) has categorised the site as 'N/A Urban Non-residential', meaning future development can proceed following normal consenting processes. While the site itself does not have a specific technical classification (TC) as it is not zoned residential, nearby residential sites are classified as TC1 where "future land damage from liquefaction is unlikely", and "shallow soil strength testing which is standard for all homes" is required (Figure 5).

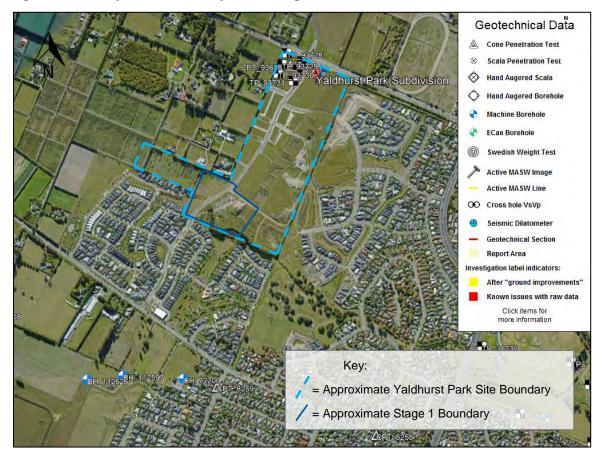
Figure 6: Publicly Available Near-by Site Investigations

CPT / Borehole Identifier	Position Relative to Site	Depth of Exploration (m)
BH_112631	100 m to the north	6.08
TP_93731	100 m to the north	2.7
TP_93730	100 m to the north	2.6
BH_72200	500 m to the south	5.27

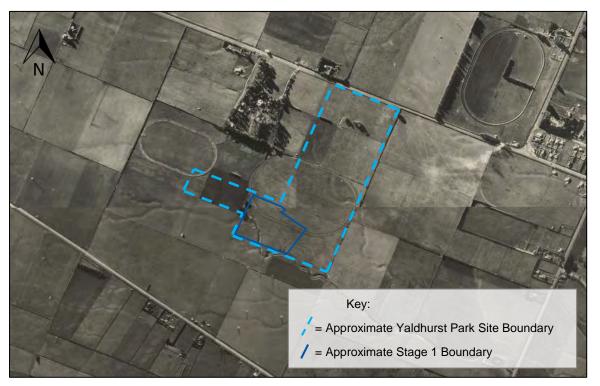
Figure 7: 1950 Aerial Photography

- Prior to 1941, the site appears to have been developed with a track for horse training and outside of the horse training track has been used for agricultural purposes. The stream locations observed in the 1941 aerial photography, appear to be in the same locations as present.
- Between 1941 and 1950, the size of the horse racing track increased (Figure 7).
- Between 1960 and 1970, a row of pylons had been constructed in the same location as the present location.
- Between 1980 and 1990, the site had been developed into an orchard (Figure 8).
- Between 2000 and 2011, the site had been cleared and the development begun for the existing subdivision.

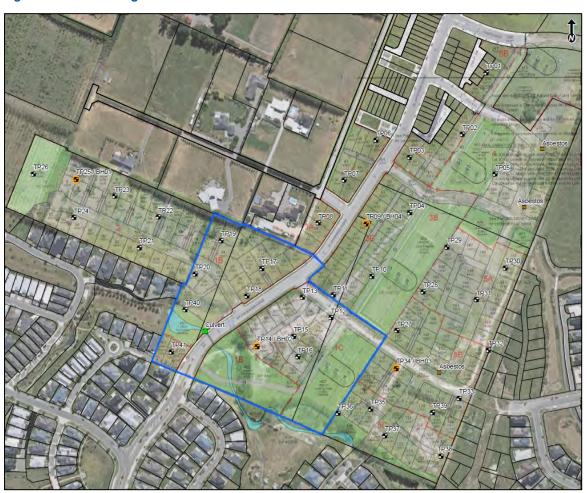
Figure 11: Site Investigation Locations

The investigations revealed subsurface conditions across the site are consistent with the published geological mapping, as summarised in Table 3.

No standing water was observed in any of the test pit excavations. Standing water was observed between 7.5 m bgl in BH02 and 9 m bgl in BH03. In both BH01 and BH04, no standing water was observed within the depth drilled, 10.91 m.
