Geotechnical Investigation - Stage 1

Yaldhurst Park

Yaldhurst

Infinity Yaldhurst Limited

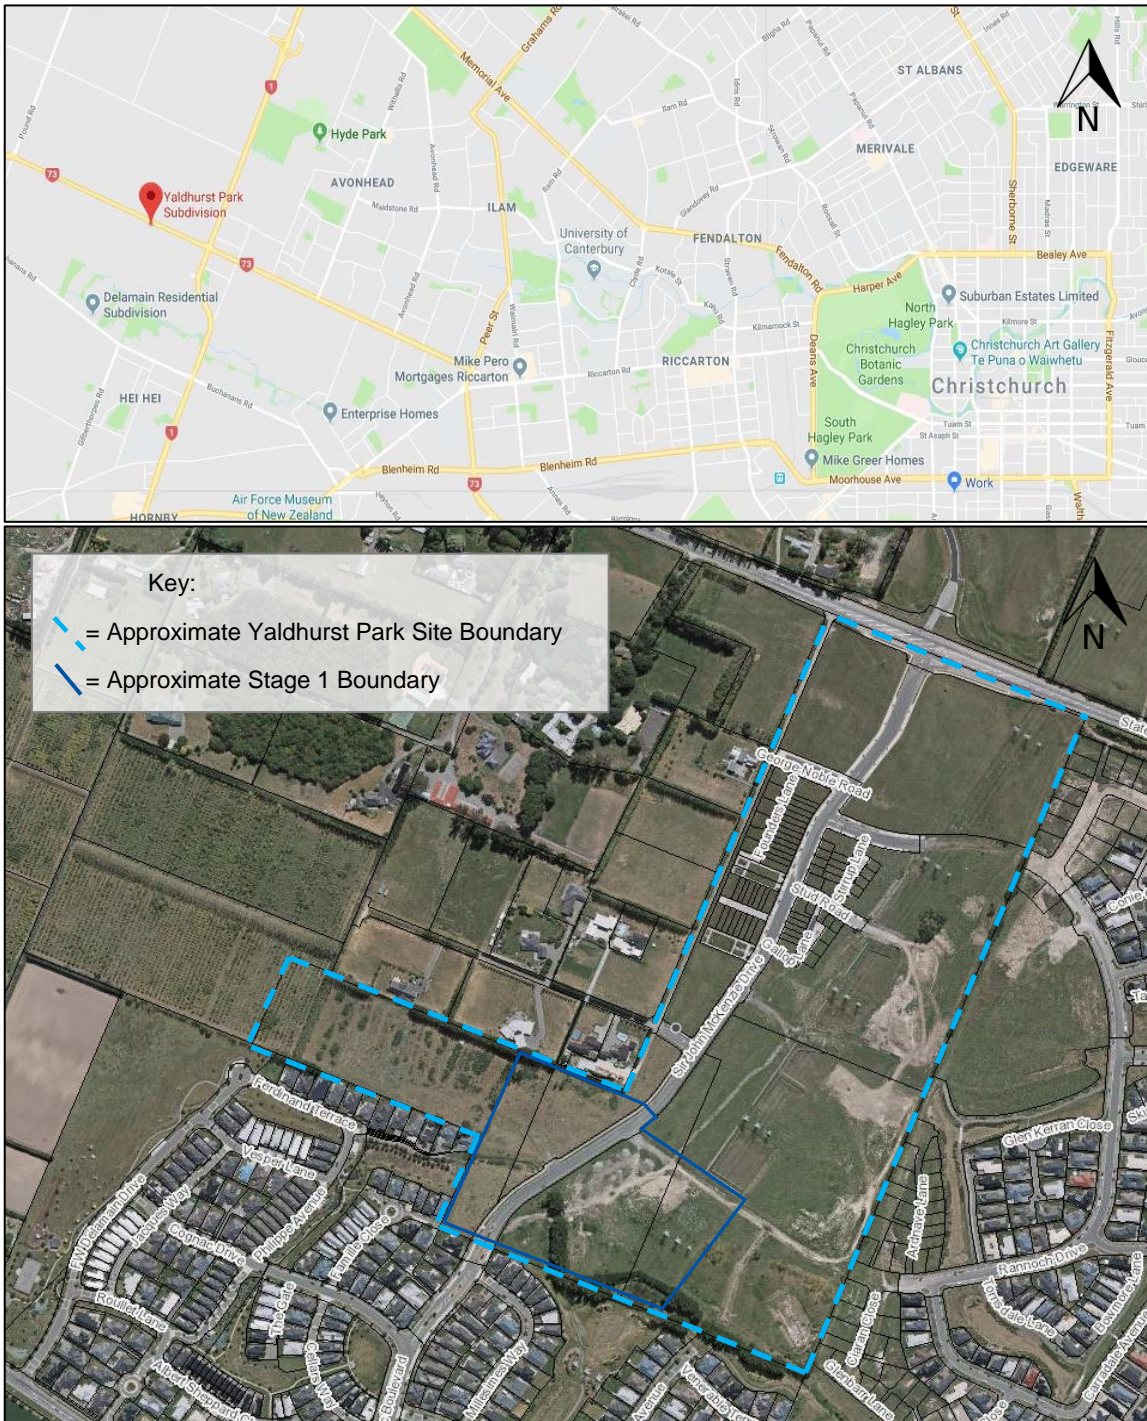
Figure 1: Site Location and Subdivision Plan

The predominantly flat, to gently undulating site is currently partially developed land with stockpiled silt, fill and unknown material observed in area '1C' on the eastern side of the proposed development (blue outline, Figure 1).

A stream, on the south-western corner of the site, is planned to be diverted during earthworks. Parks and areas of recreation are planned to run adjacent to the stream (blue solid outline, Figure 1). There are no significant mapped watercourses mapped within the vicinity of the proposed development area.

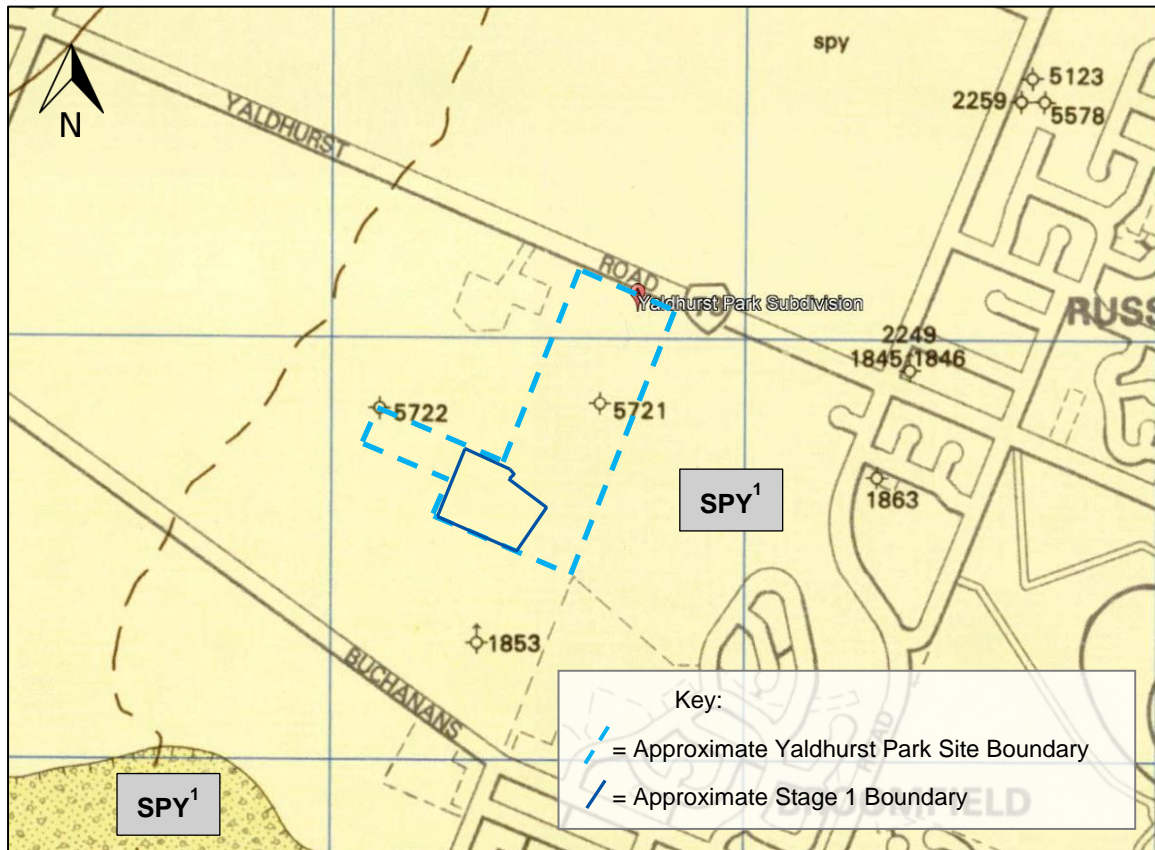
Figure 3: Site Geology

The site has been regionally mapped by Brown and Weeber (1992) as being underlain by dominantly alluvial sand and silt overbank deposits (Figure 3) and by GNS (Forsyth et al., 2008) as being underlain by river alluvium.

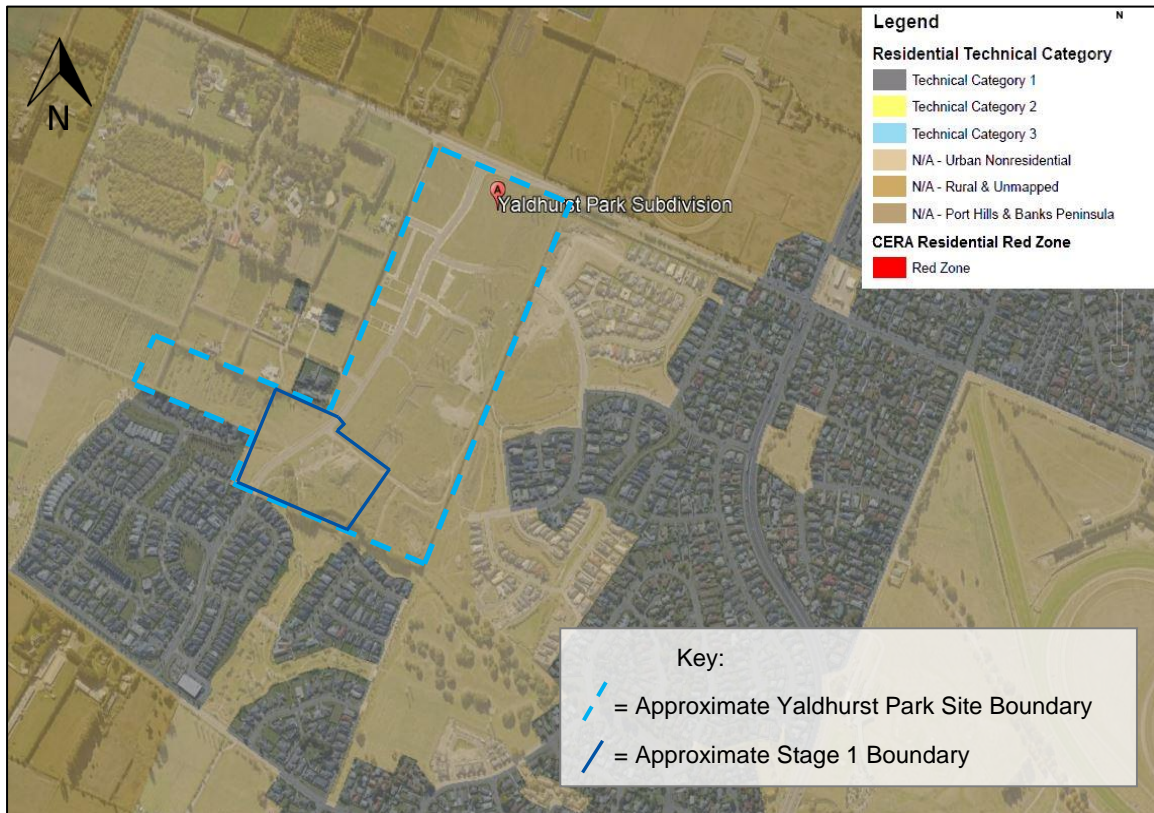
Figure 4: MBIE Residential Technical Categories Overlay

The Canterbury Earthquake Recovery Authority (CERA, now disestablished) has categorised the site as 'N/A Urban Non-residential', meaning future development can proceed following normal consenting processes. While the site itself does not have a specific technical classification (TC) as it is not zoned residential, nearby residential sites are classified as TC1 where "future land damage from liquefaction is unlikely" and "shallow soil strength testing which is standard for all homes" is required (Figure 4).

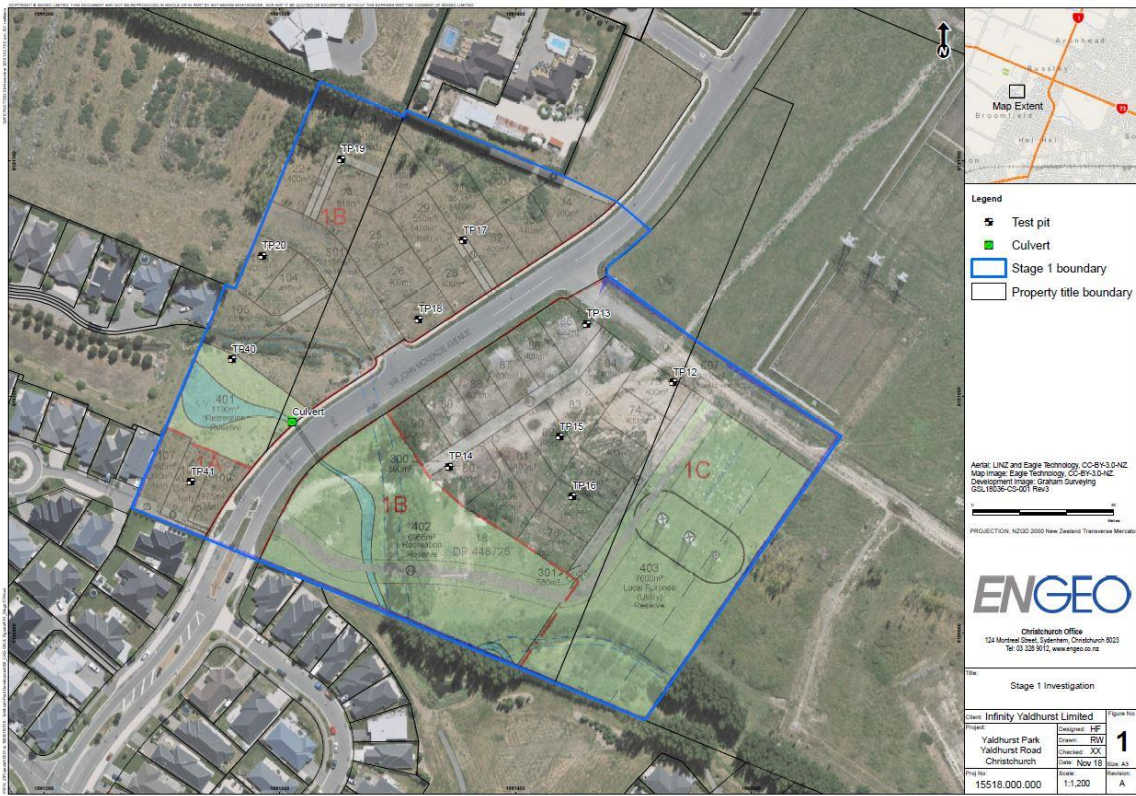
Figure 10: Site Investigation Locations

ENGEO completed a site investigation on 24 October 2018 to assess the shallow subsurface material types and strength characteristics within Stage 1 of the Yaldhurst Park Subdivision Development. The investigations comprised of 11 test pit investigations with associated Scala Penetrometer tests to assess the near surface soil types and strength characteristics. We also excavated a test pit in the location of the culvert where the stream is proposed to be relocated at the request of the client. The locations of all tests are shown in Figure 10 and our findings are detailed in the following sections.

The investigations revealed subsurface conditions across the site are consistent with the published geological mapping, as summarised in Table 3.

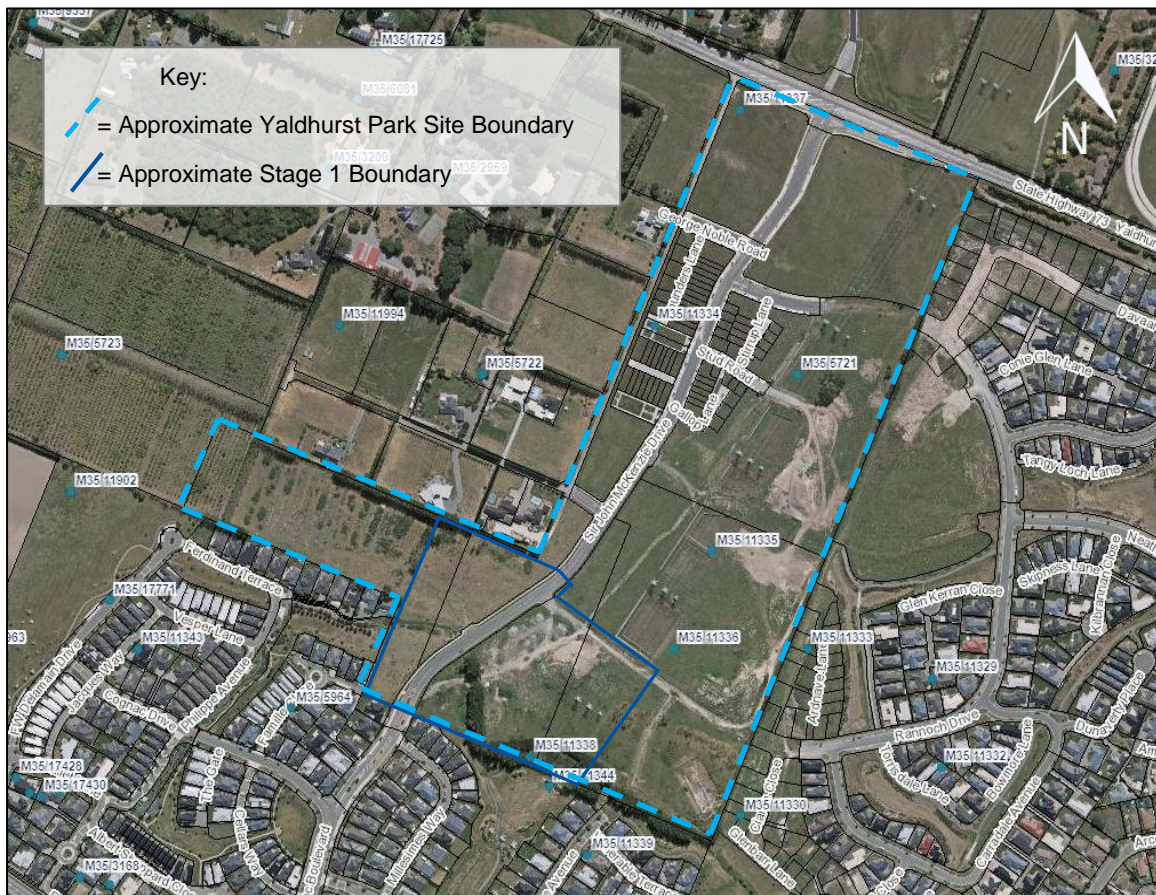
Figure 11: Nearby ECan Borehole Locations

A review of five deep ECan borehole logs located onsite, M35/5721, M35/11334, M35/11335, M35/11336 and M35/11338 was conducted (Canterbury Maps). The location of these boreholes is presented in Figure 11 and includes well points that have no log data available. The logs from all five holes of interest are presented in Appendix 3 and indicate the site is underlain by gravel and sandy gravel with thin slit and clay layers to depths of at least 15 m below ground level.

Groundwater is recorded in the surrounding ECan boreholes between approximately 13.9 m and 14.9 m depth.
